#### TWAIN HARTE COMMUNITY SERVICES DISTRICT Water & Sewer Committee Meeting

#### VIDEO TELECONFERENCE March 3, 2021 8:00 a.m.

Subject: Twain Harte Community Services District Condition Assessment Summary Date: February 24, 2021

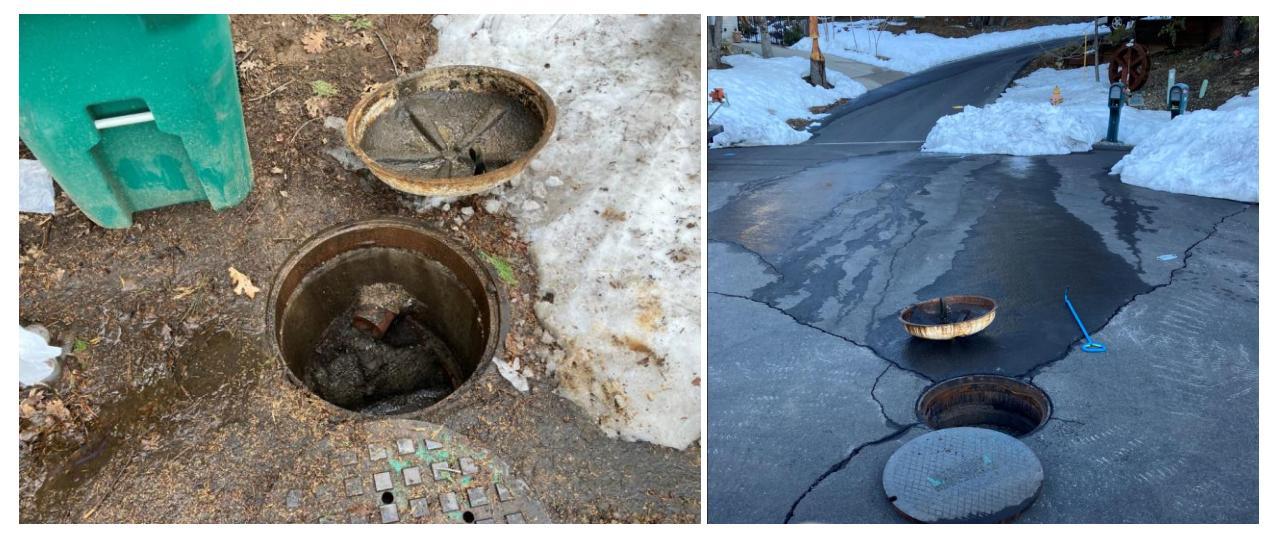
#### Figure 3: Surface runoff entering manholes in poor locations

**Figure 3** demonstrates the importance of location relative to surface runoff. Both images show surface runoff from either the street or drainage swale. In both cases, surface runoff can be seen entering manholes.

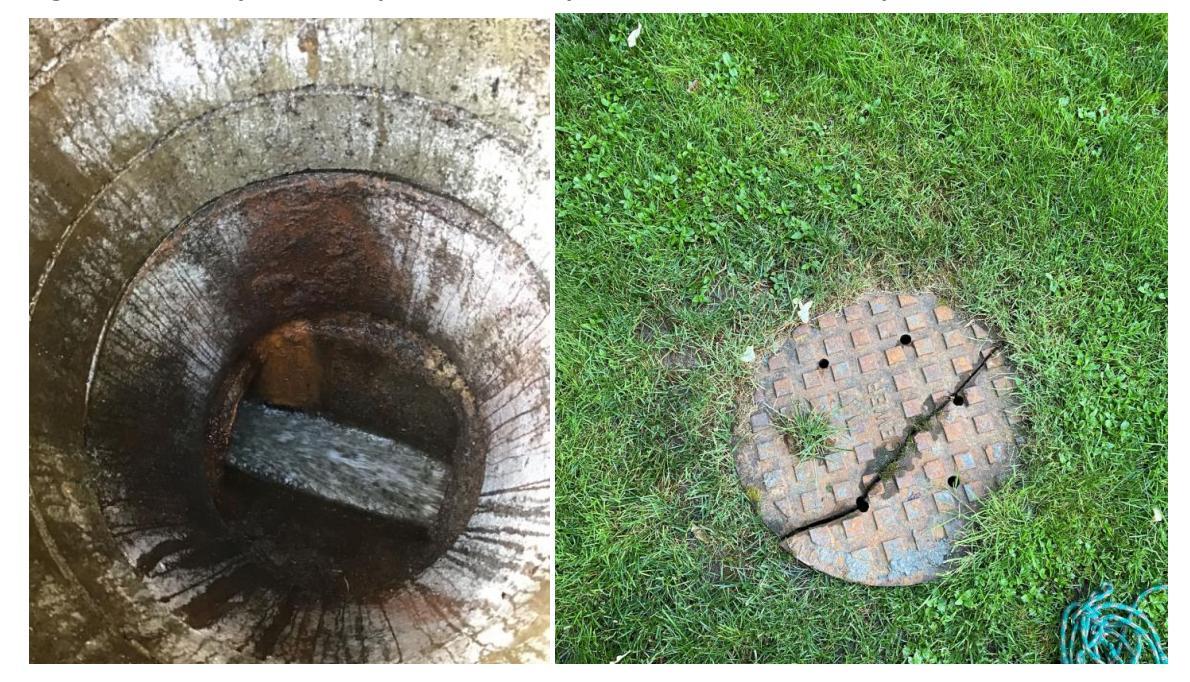
Groundwater in and around THCSD typically has high concentrations of iron and manganese. The concentrations of iron will cause a rust color to appear on the concrete at locations that experience I&I. Locations that showed this rust coloring on the interior concrete walls are a telltale sign of infiltration. The majority of manholes in the THCSD collection system are shallow and constructed of irrigation standpipe or two-foot inside diameter (ID) concrete pipe. Although these pipes are easy to install and have continued in operation, the sidewalls, bench, and frame are connected through cold joints. These cold joints are sources of I&I during storm events. (See **Figure 4**). Cracks or breaks in pipe connections to manholes are also potential sources of I&I. The MH inspection evaluated THCSD's manholes to best determine and rate these sources of I&I.

Figure 4: L buildup of iron deposits from frequent infiltration at a cold joint. R cracked MH lid.

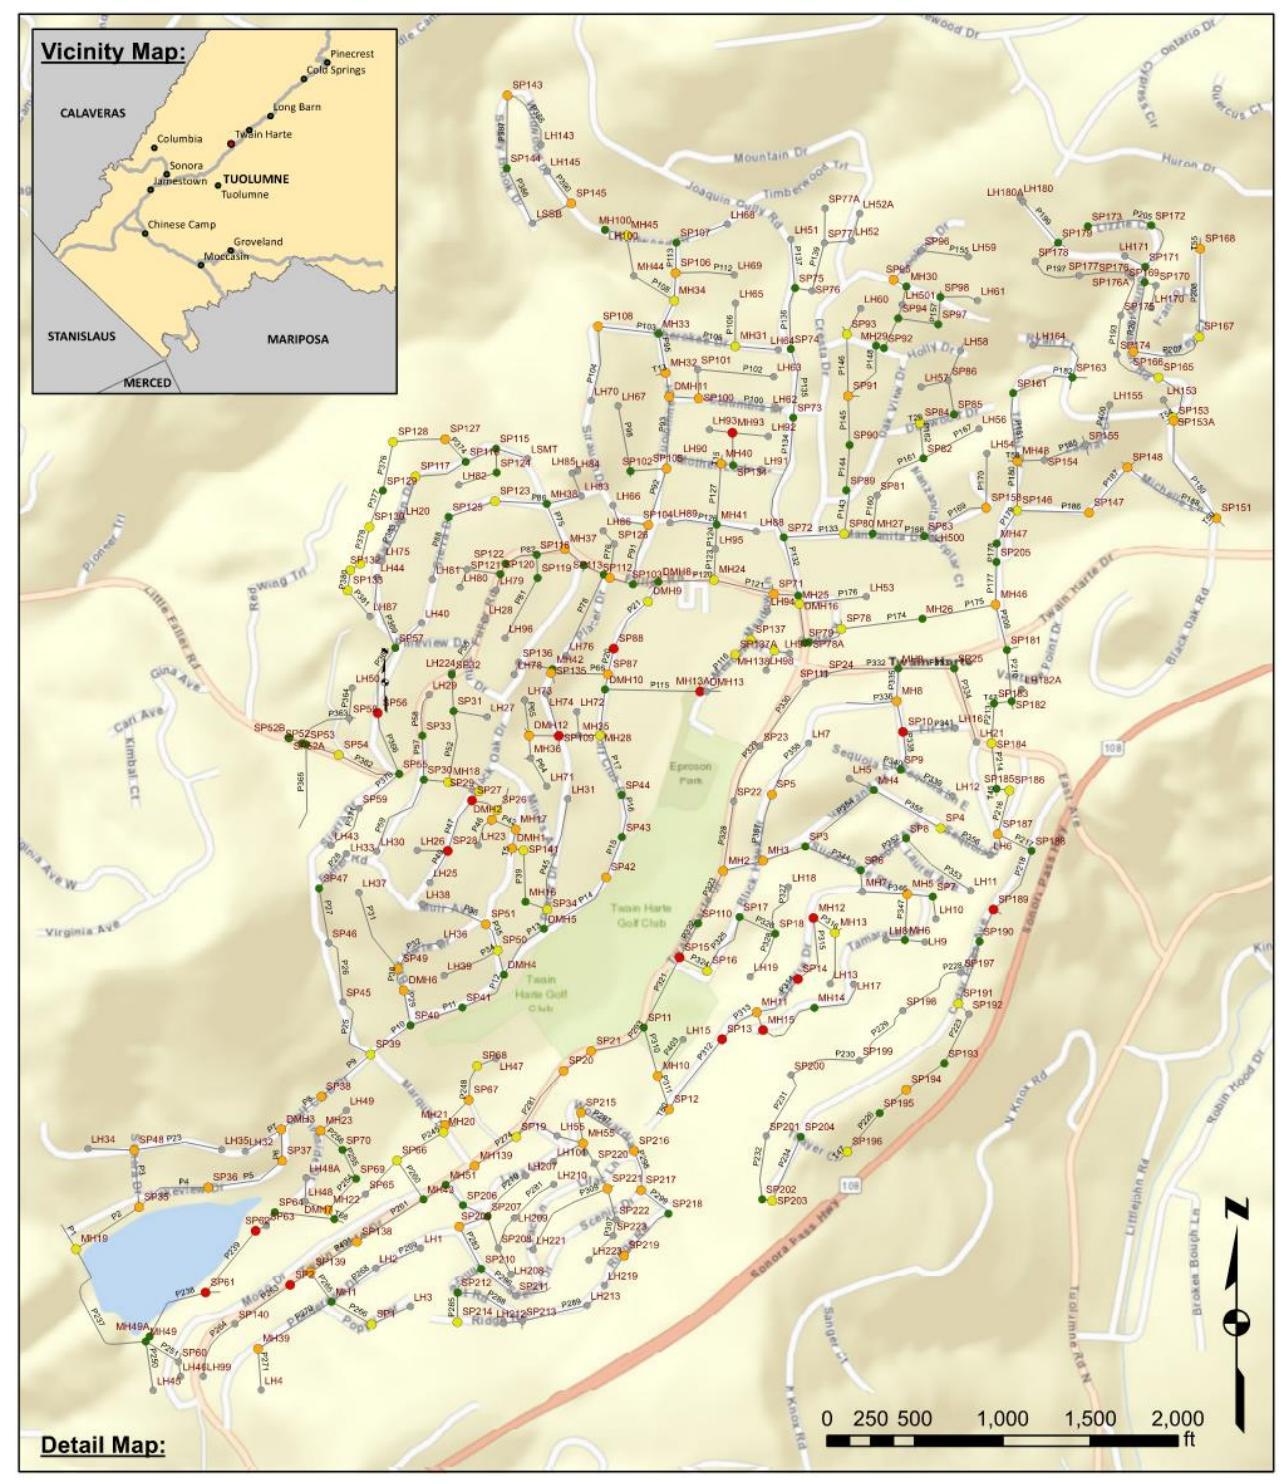
**Figure 5** shows the MHs surveyed with their priority rating. Since this evaluation aims to identify sources of I&I, high priority (red) MHs either have defects in need of immediate repair or high inflow. Medium priority items (orange) are MH's with a significant amount of inflow and in need of repairs. Low priority (yellow) represents either minor inflow and or minor repairs.

Figure 5: MH's showing urgency of repair. Red is a high priority, Orange medium priority, yellow low priority, and green no defects observed (See Attachment\_\_).

**Table 2** presents a list of MHs that were identified as potential sources of high I&I or in need of immediaterepair. Repair options are listed in the table along with location and a description of the observation.Additional manholes with lower I&I sources and lower priority are included as part of **Attachment G**.

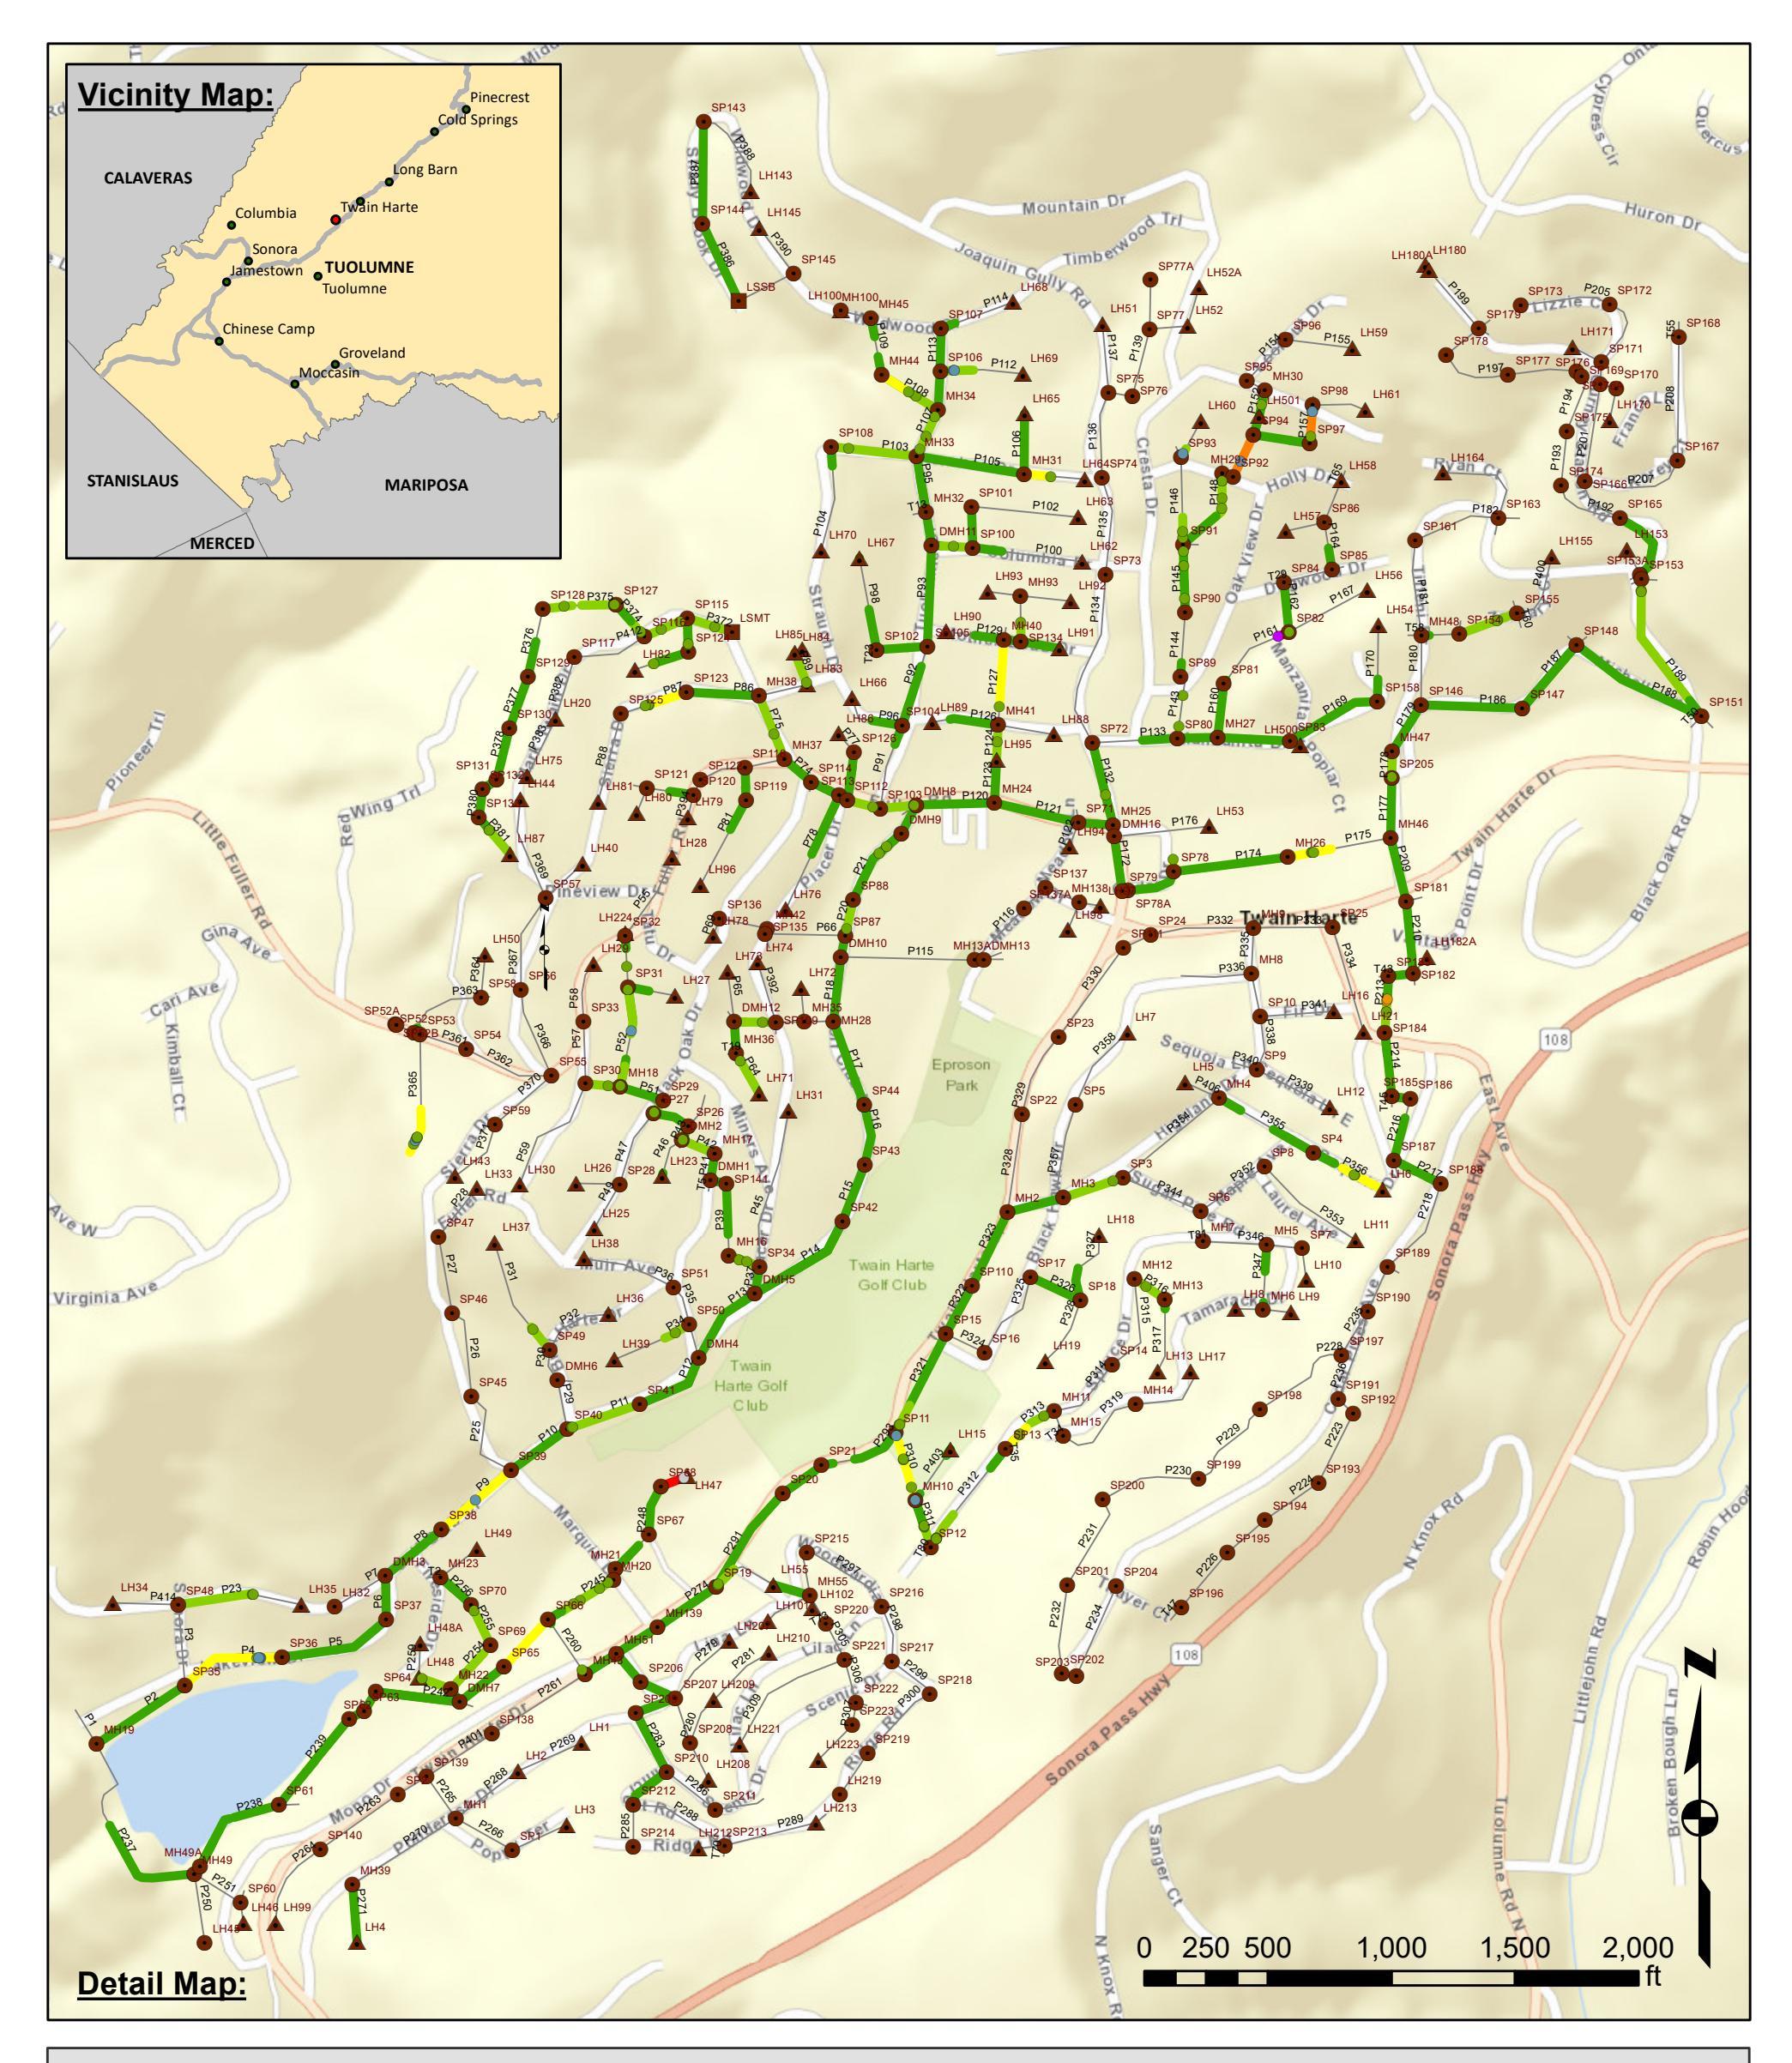
ATTACHMENT A - CCTV STRUCTURAL INDEX RESULTS

The structural index ranges from 1 to 5 with 1 being a pipe with minor defects (a score of zero indicates no structural defects detected). A high structural index indicates frequent observations such as pipe collapse, cracks, deformed pipes, holes in pipes, and joint offsets. In determining sources of infiltration, all of these structural defects are potential sources.

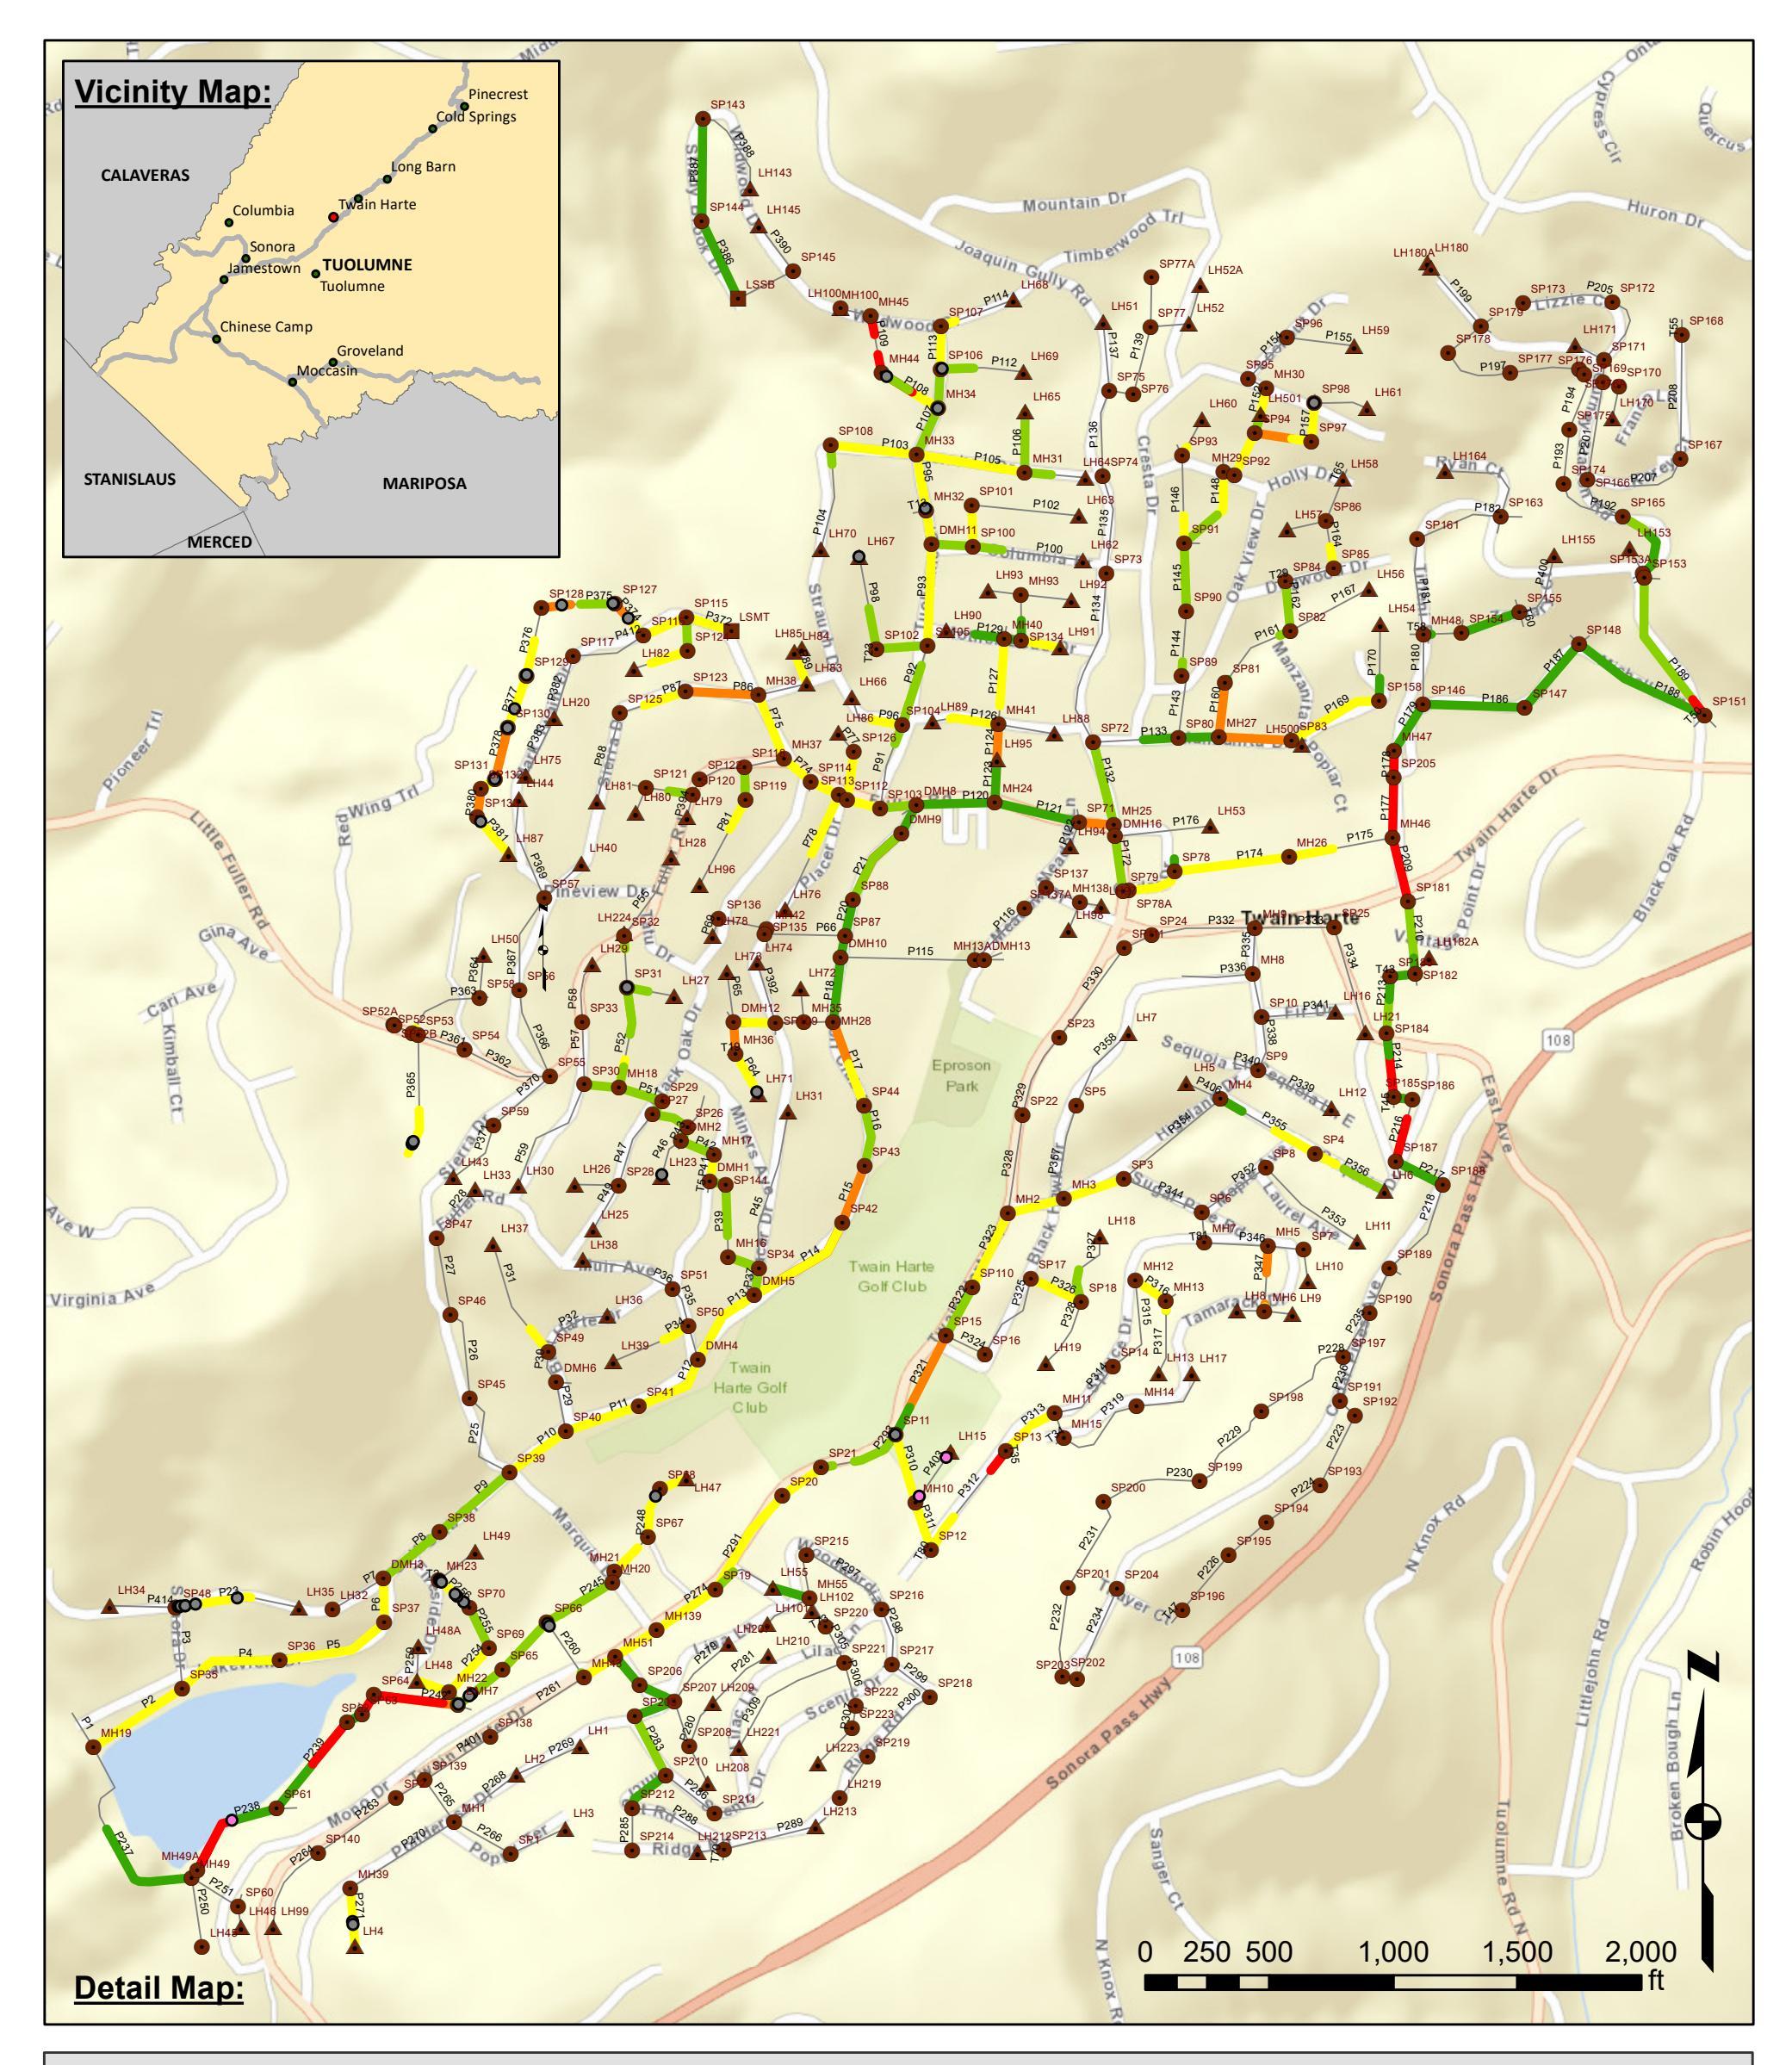
ATTACHMENT B - CCTV OPERATIONS AND MAINTENANCE

The O&M index ranges from 1 to 5 with 1 being minor observations (a score of zero indicates no O&M defects detected). A high O&M index may indicate frequent maintenance issues and includes such observations as root intrusion, infiltration, obstacles, sediment in the pipe, and vermin. While not every item in O&M will result in infiltration, the frequent observation throughout THCSD is that pipes with root intrusion and in close proximity to surface waterways can generate infiltration.
